NASA  
Technical Memorandum 107227

# Experimental Evaluation of Face Gears for Aerospace Drive System Applications

Prepared for the  
Seventh International Power Transmission and Gearing Conference  
sponsored by the American Society of Mechanical Engineers  
San Diego, California, October 6-9, 1996

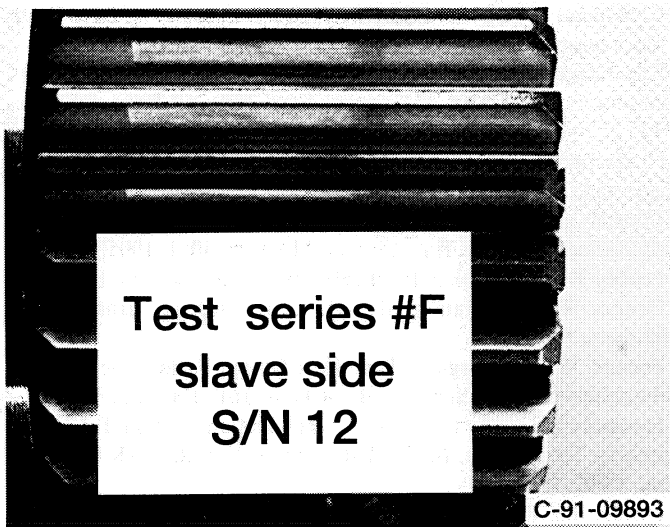
Figure 8.—Pinion from face gear set "A" after 30 million cycles at 100% load and 30 million cycles at 200 % load.

In Fig. 8 the pinion from gear set "A" after testing is shown. The contact location on the pinion is evident from the slight polishing of the surface, however no damage to the surface occurred. This type of pinion condition was typical for all the tests conducted.
